An Update on the Harbour Area Treatment Scheme (HATS)

Drainage Services Department

July 2018

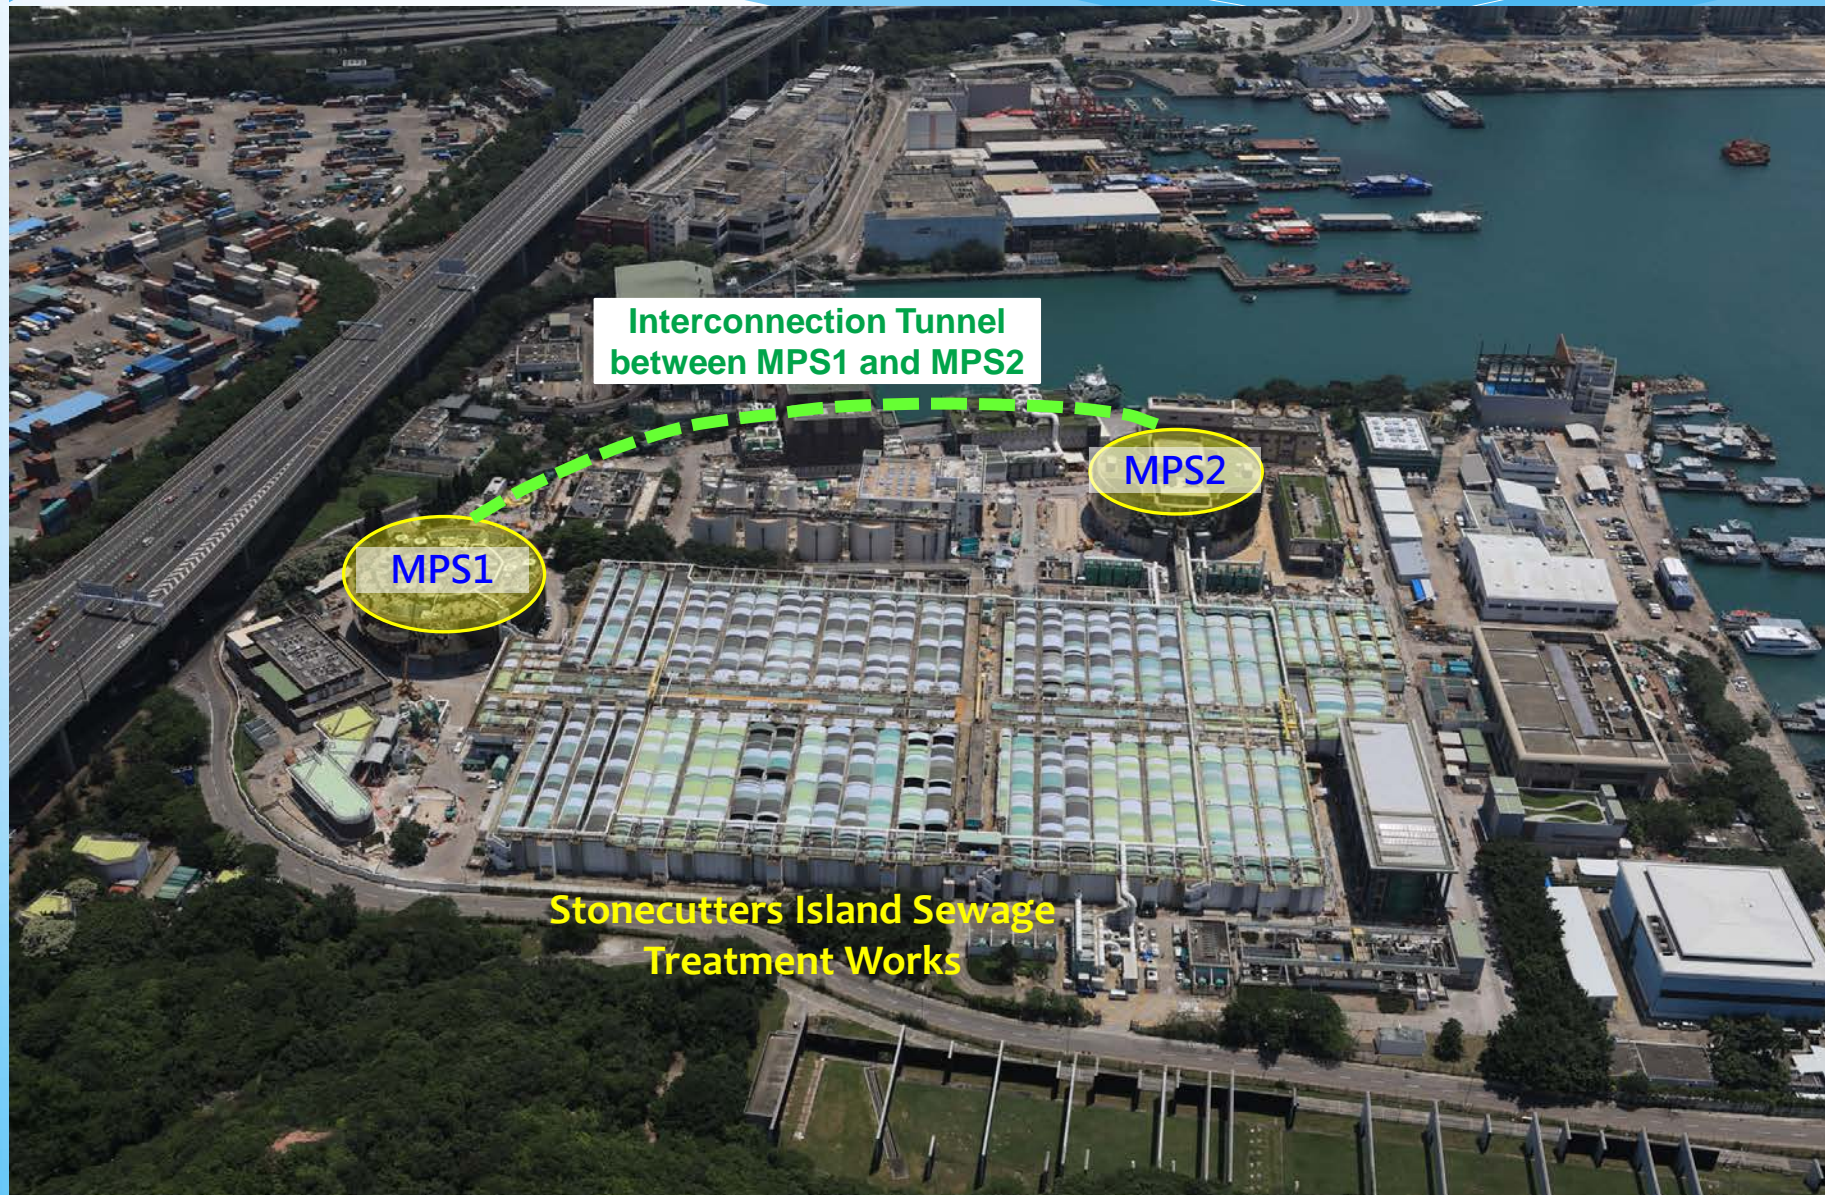
Interconnection Tunnel
between MPS1 and MPS2

MPS1

MPS2

Stonecutters Island Sewage
Treatment Works

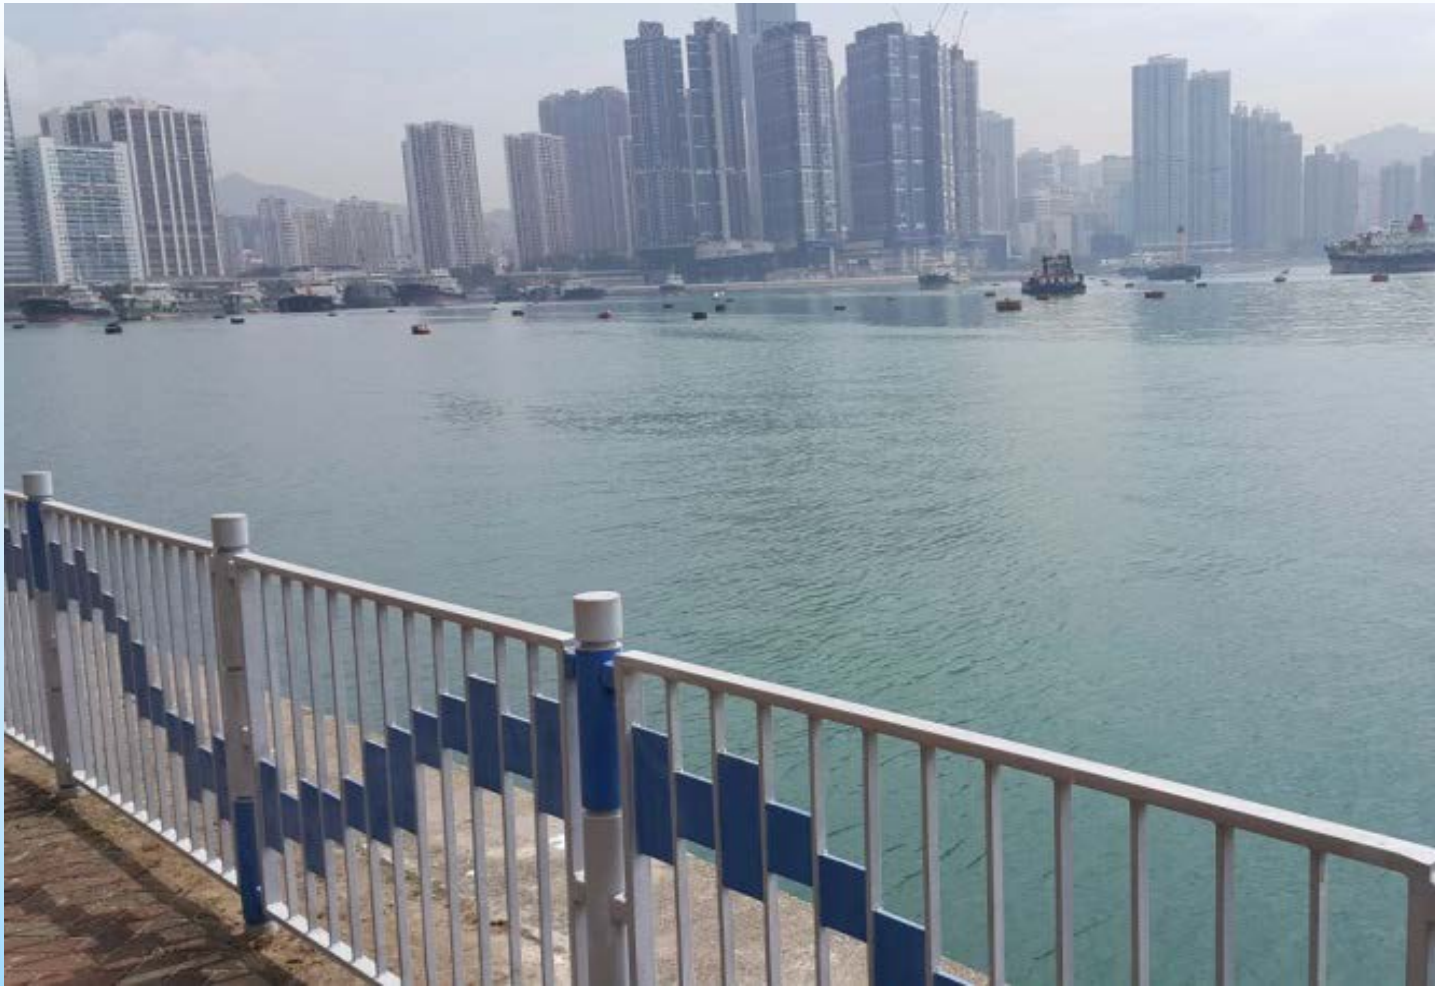
Tsuen Wan Promenade

Conditions during the 1st bypass

- 17 years of unceasing operation since 2001
- Temporary sewage bypass (in non-bathing season, 5 episodes each not exceeding 2 weeks)
- Water Quality Modelling – potential impact low and transient
- Consultation with the ACE and the LegCo EA Panel
- Inter-departmental working group
- First bypass completed (20 Feb – 4 Mar 2018)

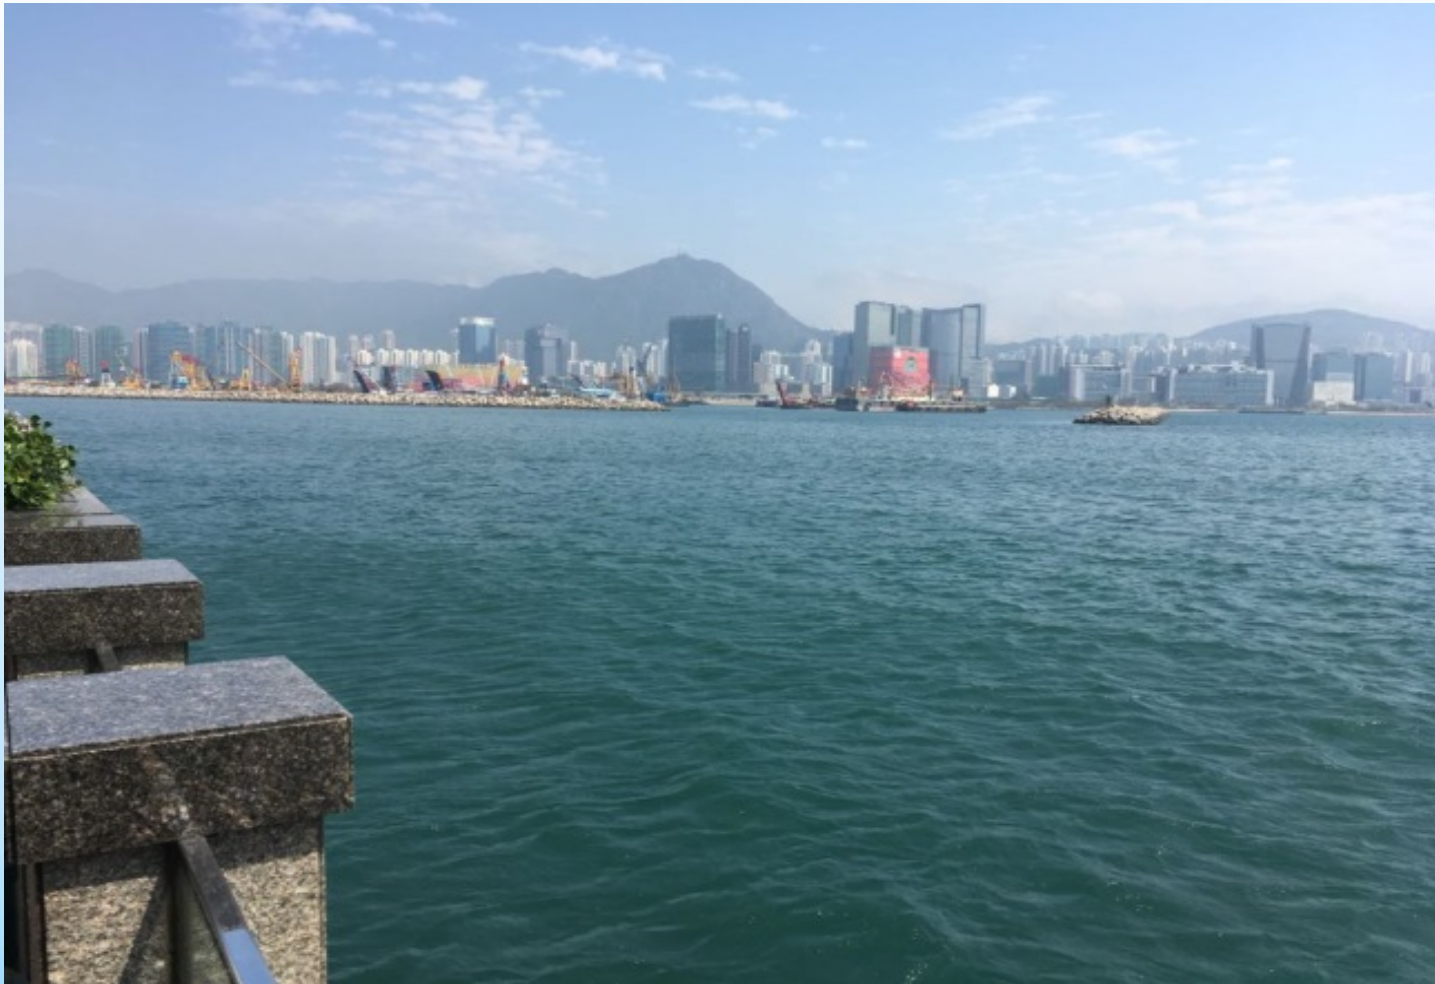
Hung Hom Promenade

Conditions during the 1st bypass

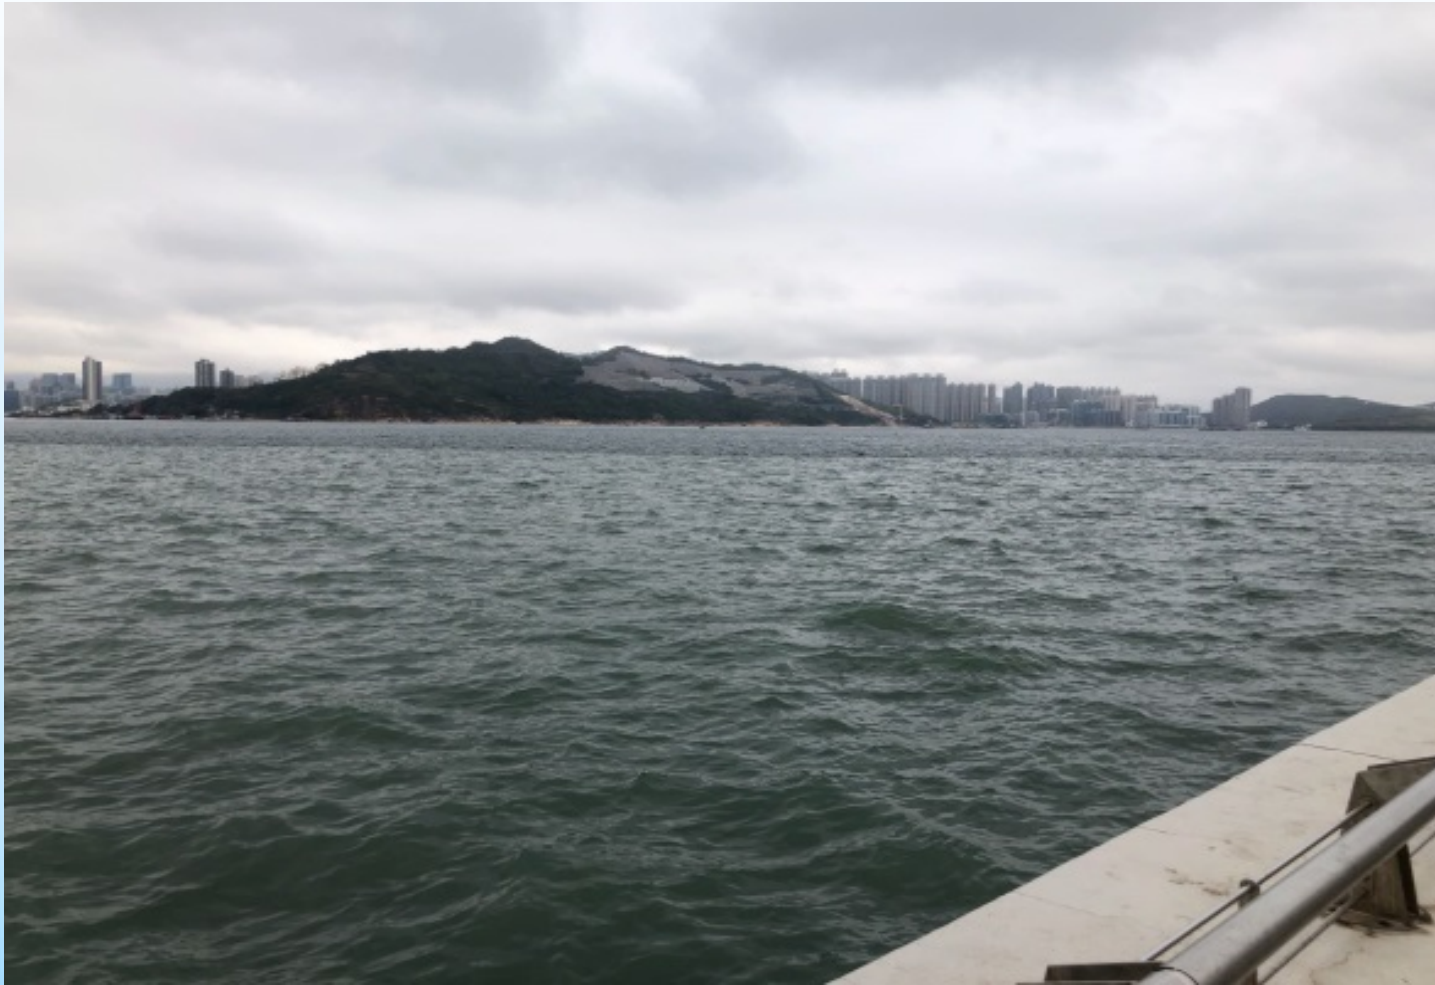
Siu Sai Wan Promenade

Conditions during the 1st bypass

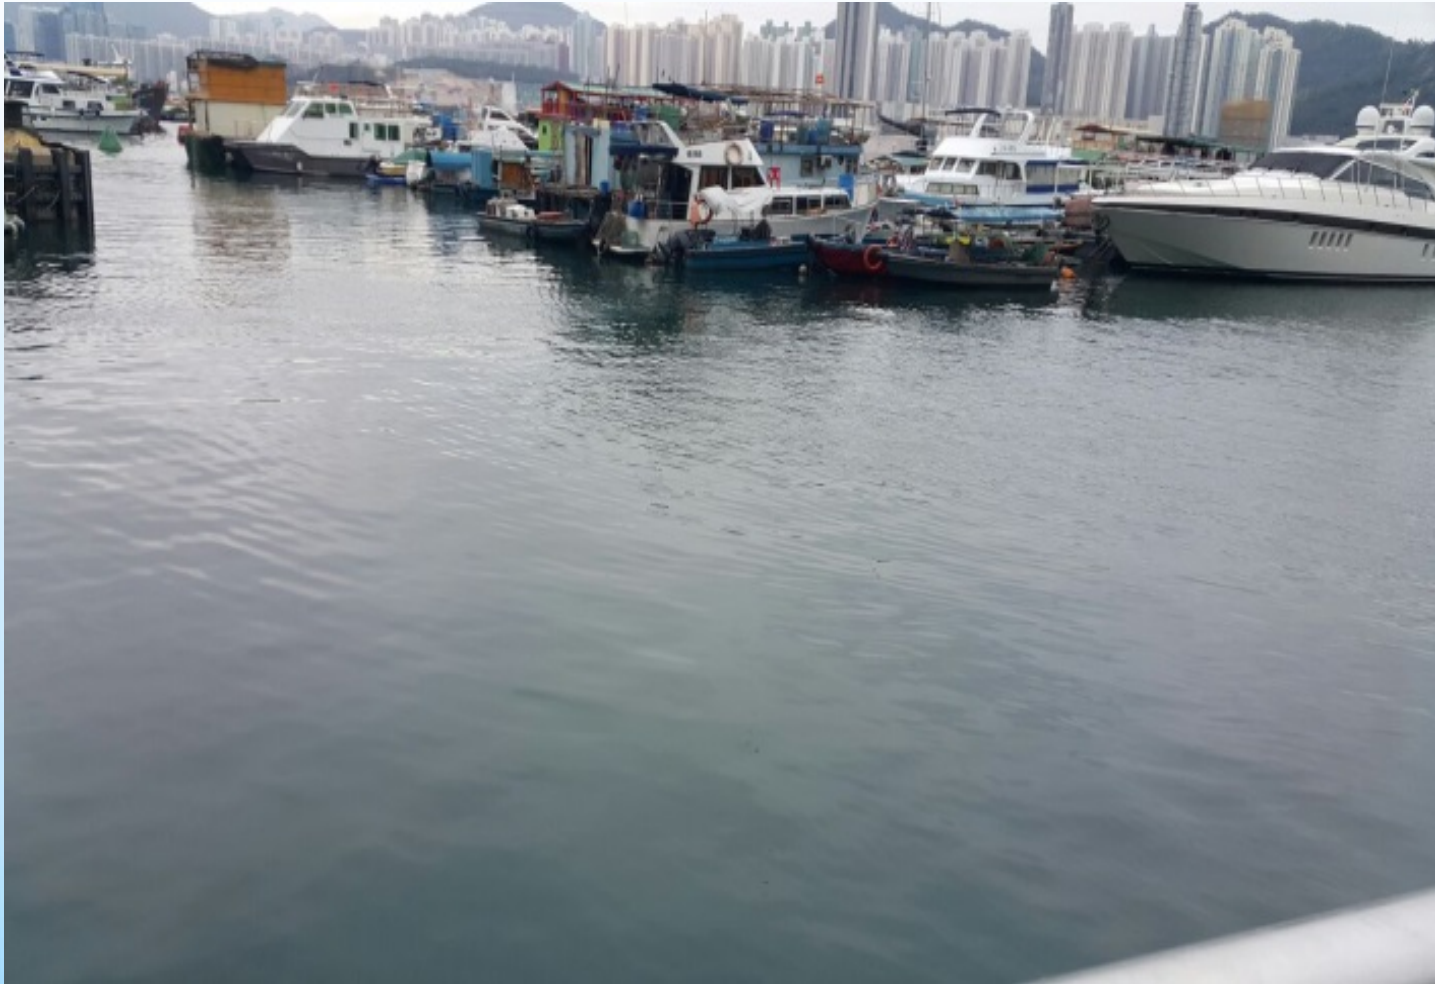
Aldrich Bay Promenade

Conditions during the 1st bypass
